M6 Propellant/Explosive Storage Photos  
Explo Systems, Camp Minden, LA

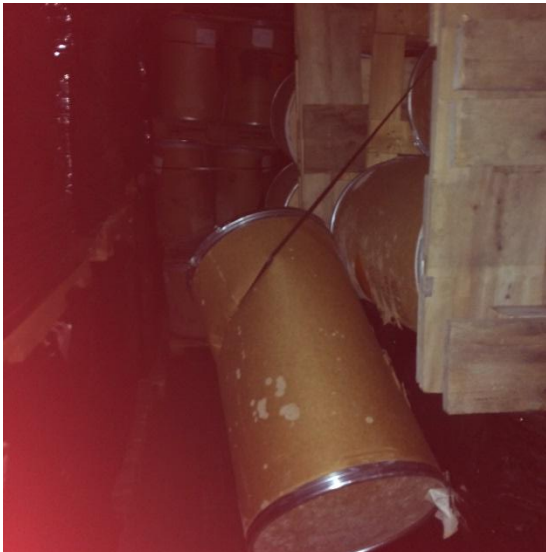
Photo 1: Several pallets (containing M6 or other explosives) fallen forward with one drum hanging from strap approximately 3 feet from magazine floor. (Photo taken May 21, 2014)

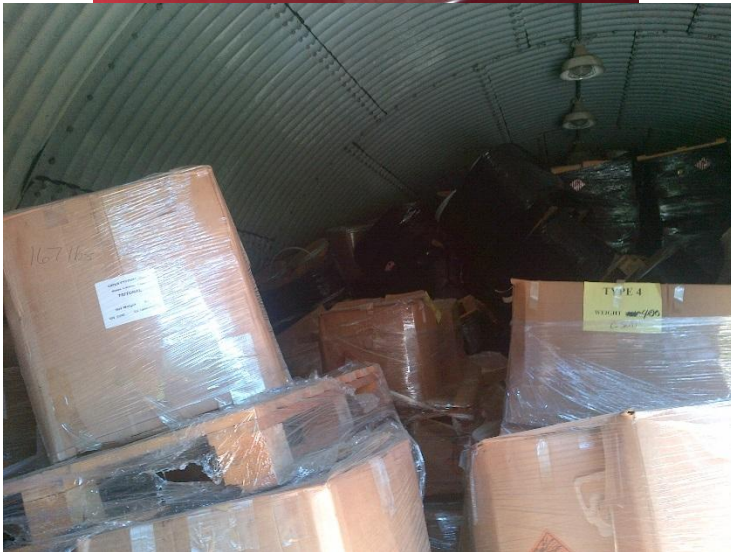
Photo 2: Pallets of aluminum/TNT/Tritonal stacked 4-5 pallets high, leaning against each other/magazine walls, collapsing, and falling over. (Photo taken June 11, 2014)

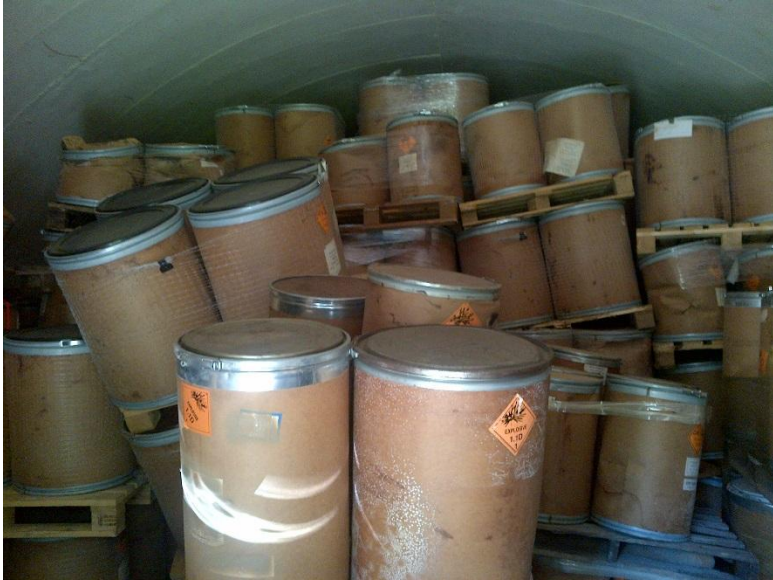
Photo 3: Drums of M6 propellant or other explosive material on pallets, stacked 3-4 pallets high, leaning against each other/magazine walls, collapsing, and falling over. (Photo taken June 11, 2014)

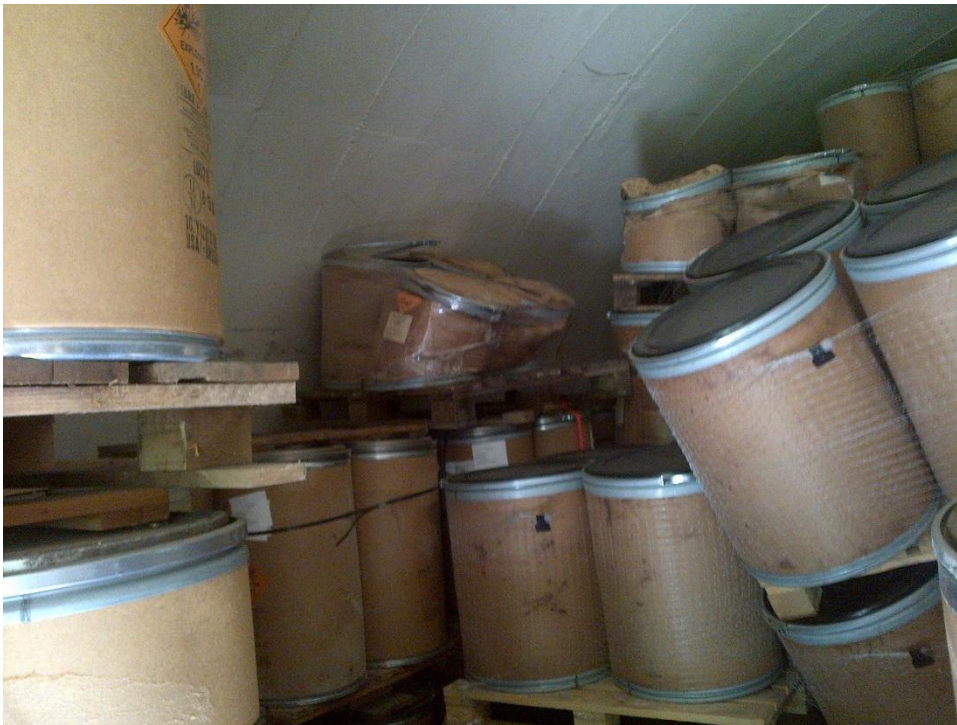
Photo 4: Drums of M6 propellant or other explosive material on pallets, stacked 3-4 pallets high, leaning against each other/magazine walls, collapsing, and falling over. Several drums are visibly crushed. (Photo taken June 11, 2014)

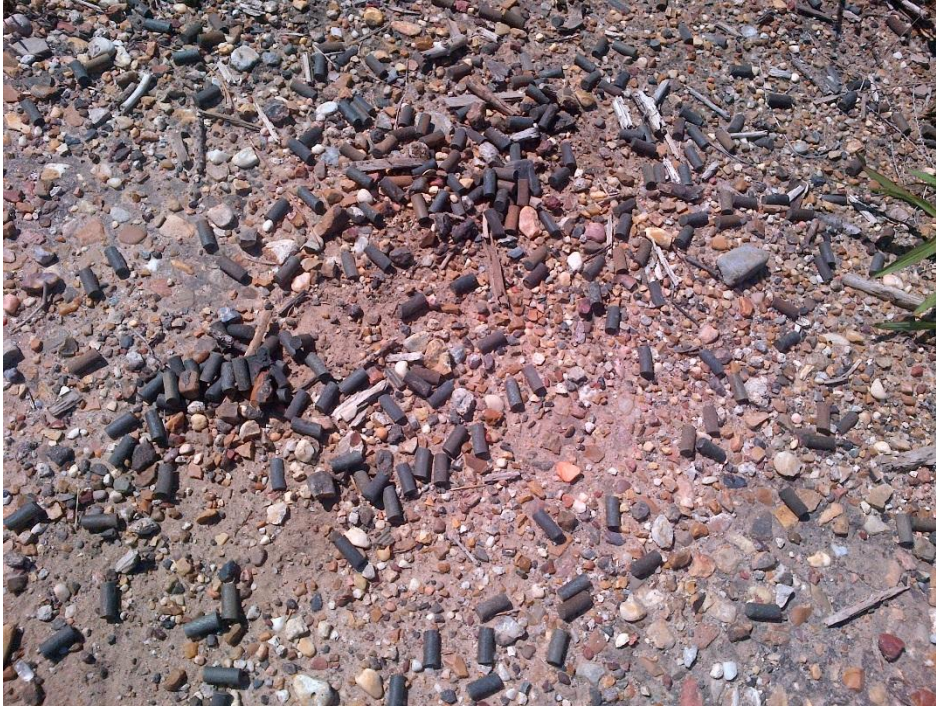
Photo 5: M6 propellant found on the ground outside an explosive storage magazine. Spilled/released explosive material is commonly found in and around magazines due to poor housekeeping/previous explosive incidents. (Photo taken June 11, 2014)

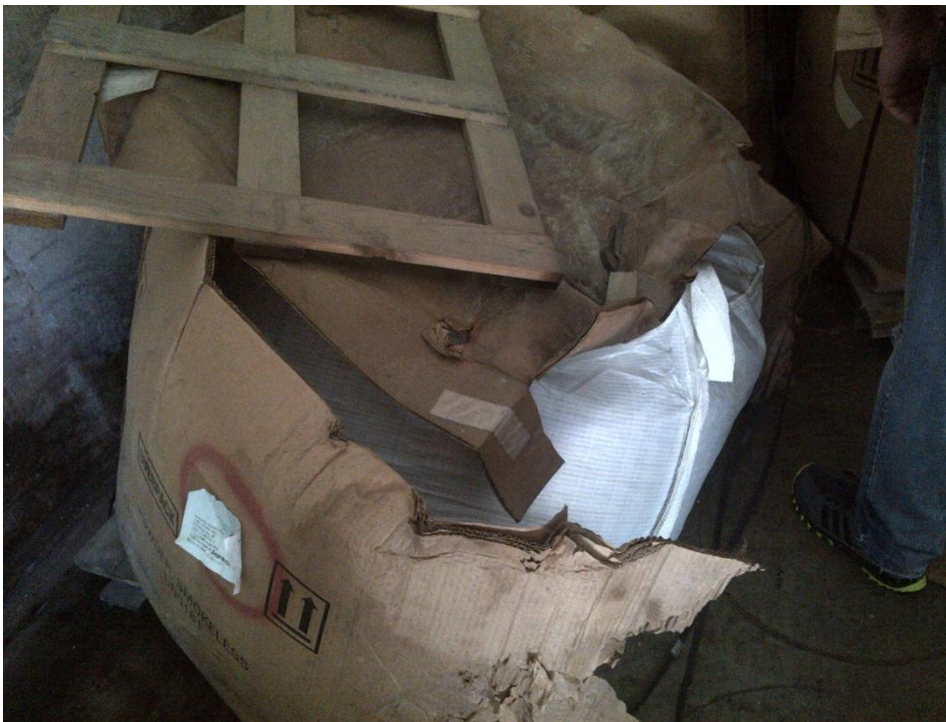
Photo 6: M6 propellant stored inside an 880 lbs. super sack and cardboard box. Visibly weathered cardboard box is torn/crushed. Weathered, crushed, and damaged fiber containers are common within the storage magazines containing Explo related material at Camp Minden. (Photo Taken June 11, 2014)

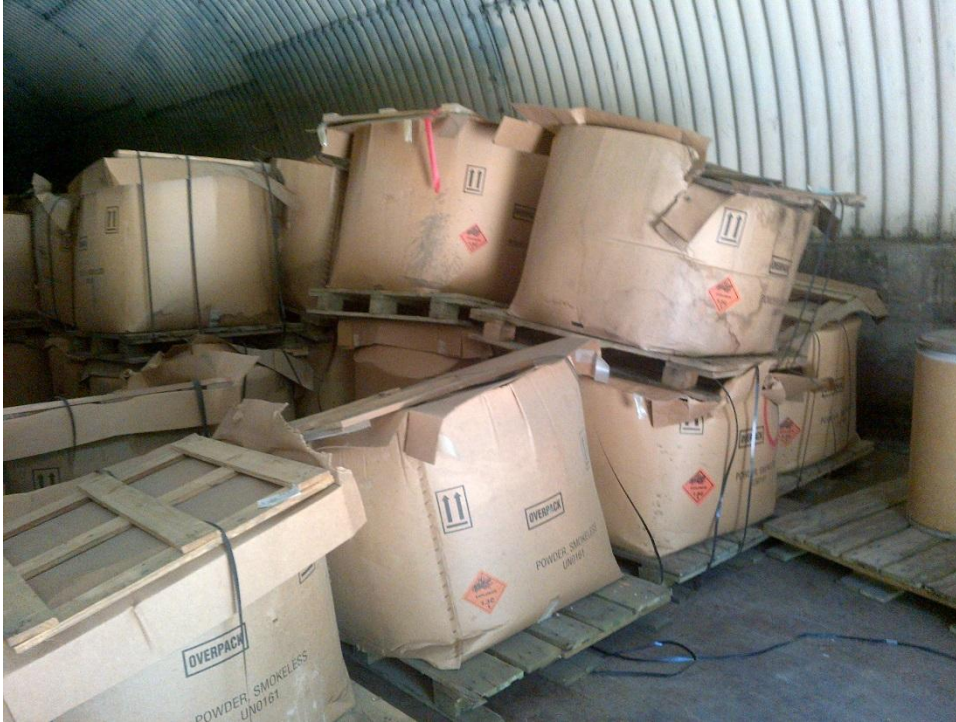
Photo 7: M6 propellant stored inside an 880 lbs. super sack and cardboard box. Visibly weathered cardboard box is torn/crushed. Weathered, crushed, and damaged fiber containers are common within the storage magazines containing Explo related material at Camp Minden. (Photo Taken June 11, 2014)

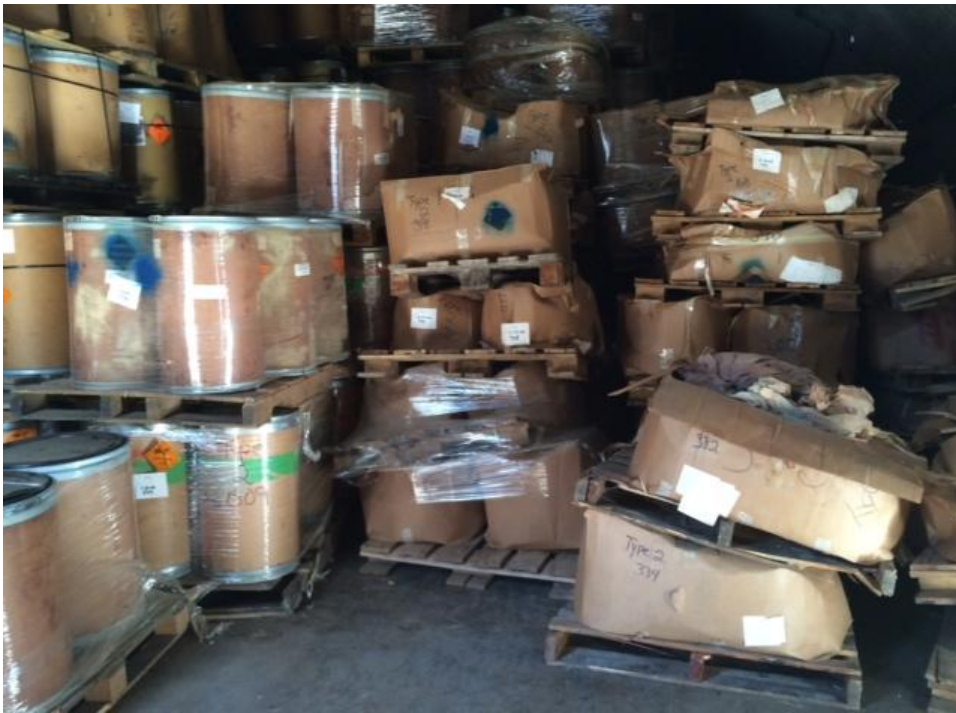
Photo 8: Drums and boxes of aluminum/TNT/Tritonal mixture or other explosive material on pallets, stacked 3-5 pallets high, leaning against each other/magazine walls, collapsing, and falling over. Several containers are visibly crushed and some are releasing their contents. (Photo taken January 16, 2014)

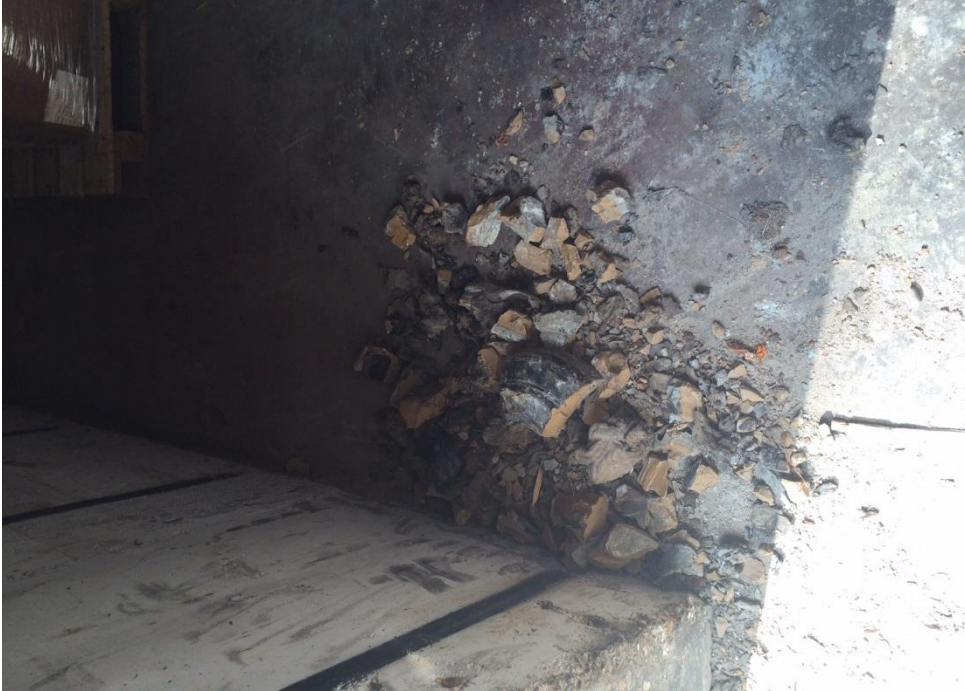
Photo 9: Aluminum/TNT/Tritonal found on the ground inside an explosive storage magazine. Spilled/released explosive material is commonly found in and around magazines due to poor housekeeping/previous explosive incidents. (Photo taken May 21, 2014)
